BACK TONATURE

Rehabilitating aging infrastructure in environmentally sensitive areas

Kenneth H. Nilsen and Peter Sanchez

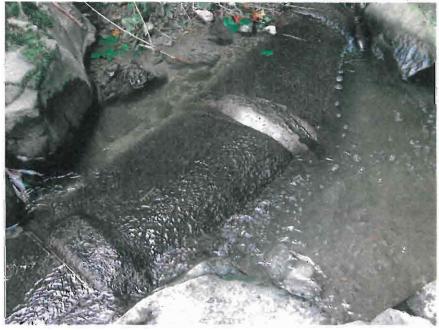
District staff discovered that sewer lines and several manholes, which previously were buried beneath the stream, had been exposed. PACE Engineers/SWSSD

During a maintenance walk in June 2007, following a winter of record rainfall, district staff discovered that several manholes in the Miller Creek ravine were now fully exposed to high stream flows, and that an unrestrained 22.5-degree vertical-horizontal bend that had previously been buried 1.2 to 1.5 m (4 to 5 ft) below the stream was exposed and in jeopardy. Any further down-cutting or movement of this sewer line could lead to a total separation of the trunk line, causing catastrophic environmental impacts to a major salmon spawning creek.

The district was previously aware that the streambank near Manhole (MH)-12 had eroded, leaving the upper 1.5 m (5 ft) of the manhole fully exposed to high stream flows. In this June 2007 inspection, the district staff noted that a portion of the sewer trunk line near MH-15 also was exposed. Following that initial reconnaissance, PACE Engineers Inc. (Kirkland, Wash.) was contracted to conduct a topographic survey of the stream and sewer line from MH-11 to MH-17, and identified approximately 43 m (140 ft) of pipe that were at risk of damage. The project team believed this risk would be very high if corrective action was not immediately taken before the 2007 winter flows.

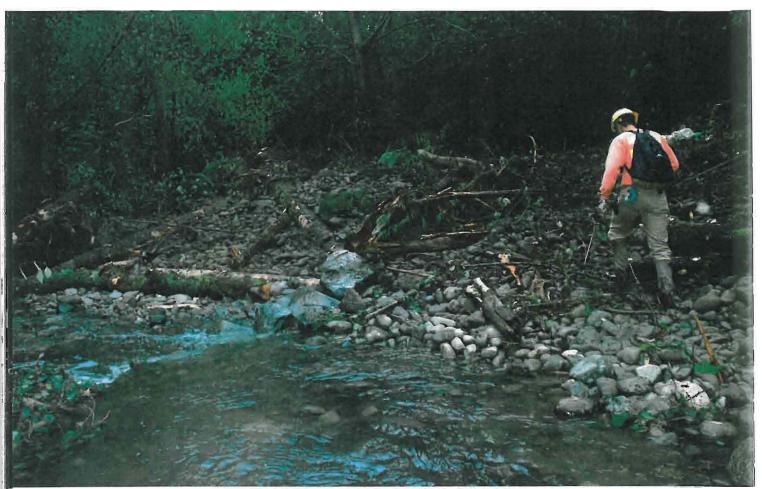
Post-construction, the stream channel has been raised to its 1966 conditions and constructed to minimize future erosion. PACE Engineers/SWSSD

protect the sewer trunk line, it was imperative that the stream channel be raised to its historic (1966) conditions and that it be constructed in such a way that the stream velocities under anticipated winter flow conditions would not erode and down-cut the channel in the area of the repair. This could be done by strategically placing boulders and large woody debris along with appropriately sized streambed gravel into the stream.
