Washington, D.C.
March 27-31, 2011

Paper D-5-01

REDUCING PROJECT UNCERTAINTY FOR RESIDENTIAL SEWER CURED-IN-PLACE-PIPE (CIPP) PROJECTS

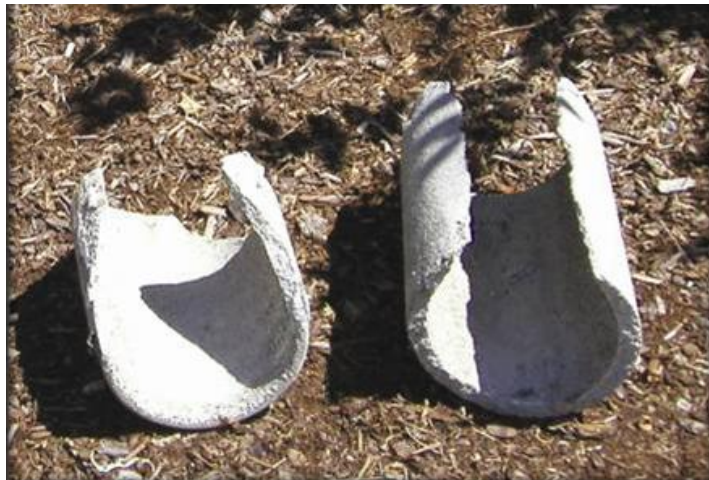
Figure 1. Existing sewer pipe from Chelsea Park Sewer Rehabilitation Project.

Figure 1 shows two sections of existing pipe that were discovered during the CCTV inspection of the sewer lines in the Chelsea Park neighborhood. The bottom section of these pipes had completely eroded away. These sections of pipe were only discovered because the CCTV camera disappeared during the inspection. These sections could not be lined using CIPP technology and were dug up and repaired using conventional open-trench construction.

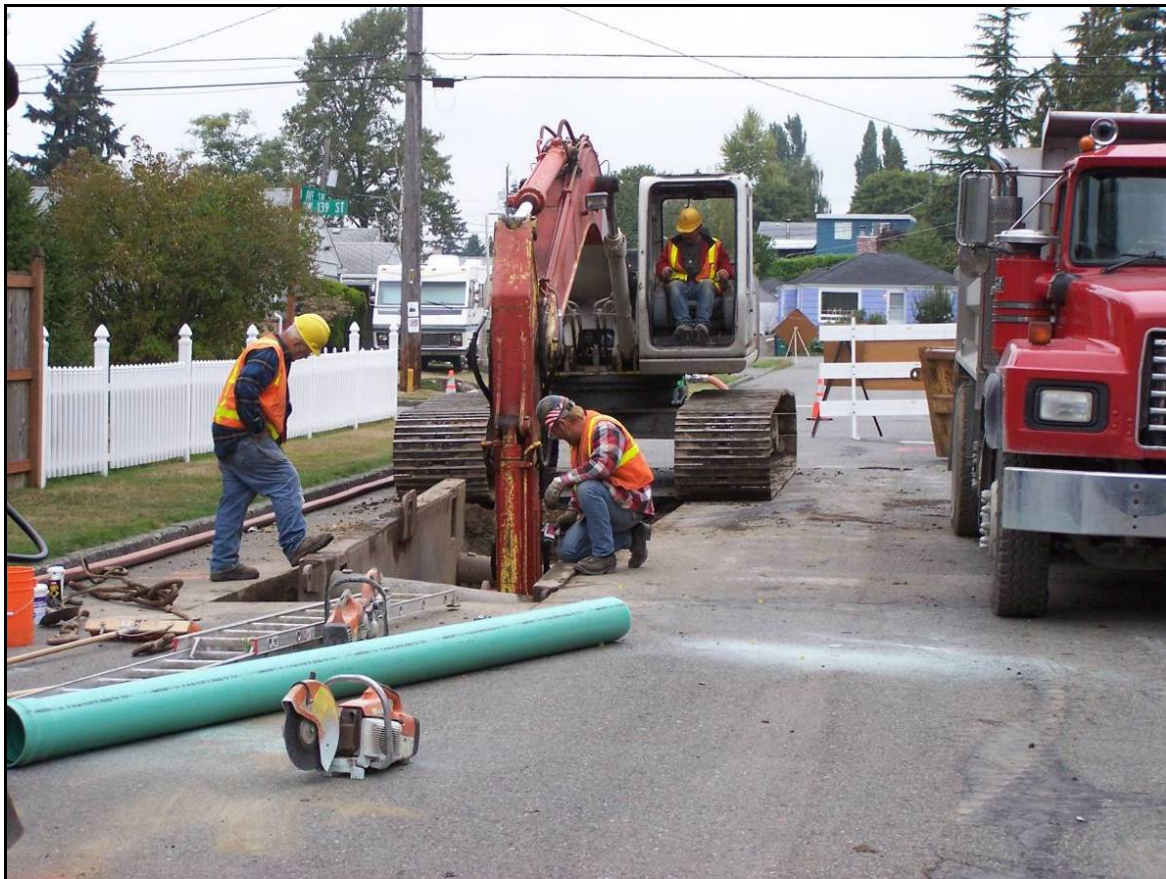
Figure 3. Spot Repair/Pipe Replacement Construction

The repair/replacement contract consisted of all the open-trench excavations that were required based on the CCTV review. These open-trench repairs replaced severely sagged pipe, removed pipe that had collapsed and replaced pipe that was undersized. Generally, the contractors bidding the repair/replacement project were local contractors familiar with SWSSD and the local road and land use agency requirements. This meant that these contractors understood the risks and requirements for constructing the project in the area and did not need to inflate their bids to cover those factors.

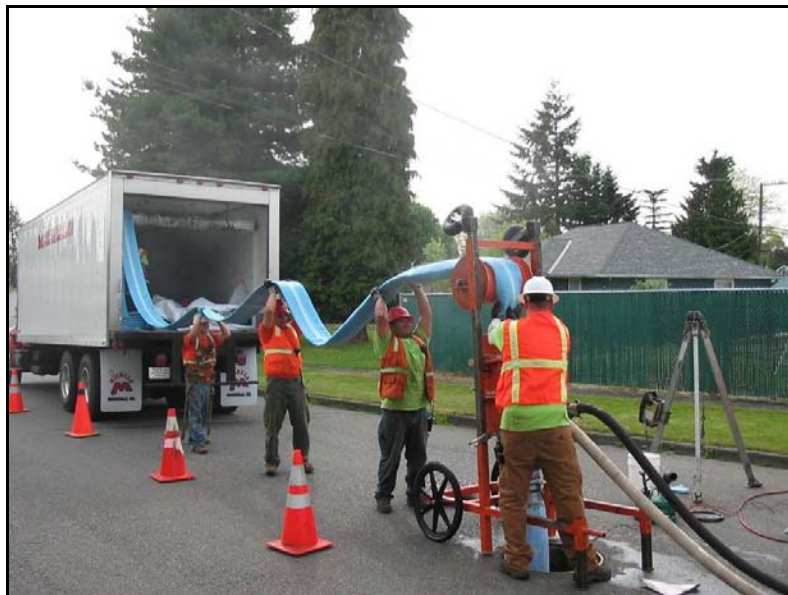
Figure 5. CIPP Rehabilitation
