BACK TONATURE

Rehabilitating aging infrastructure in environmentally sensitive areas

Kenneth H. Nilsen and Peter Sanchez

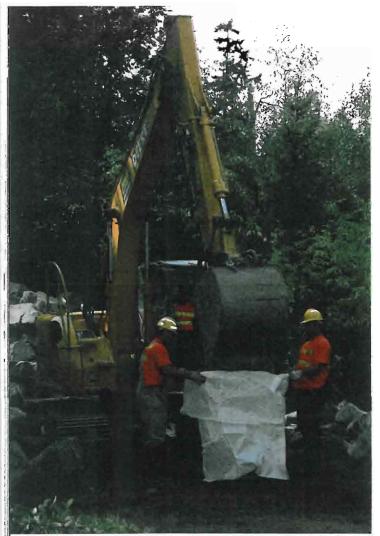
Boulders were bagged at the staging area and then airlifted to the project site. PACE Engineers/SWSSD

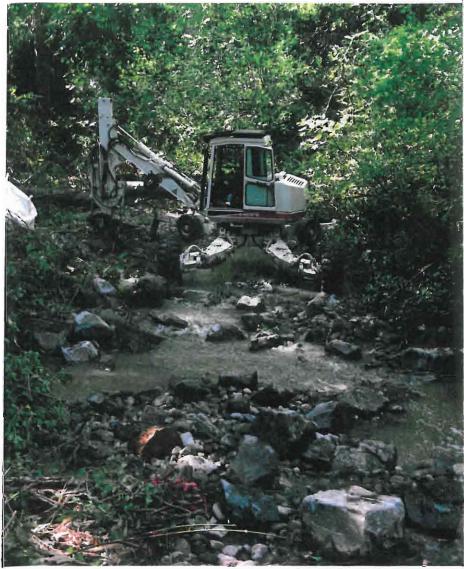
The Spyder Hoe excavator was chosen for its ability to "walk" up the creek channel with minimal environmental disruption. PACE Engineers/SWSSD

To minimize impacts to the stream, riparian corridor, and sewer line, the project team had recommended that the placement of material be done with a special excavator called a Spyder Hoe. This equipment, unlike a tracked hoe, would be able to "walk" up the creek channel as well as "step" over obstructions as high as 1.5 m (5 ft) with few or no environmental impacts, and perform the necessary excavations and material placement without placing any extraneous loads on the existing sewer pipe. A Hillsboro, Ore., company was contracted to provide these services.

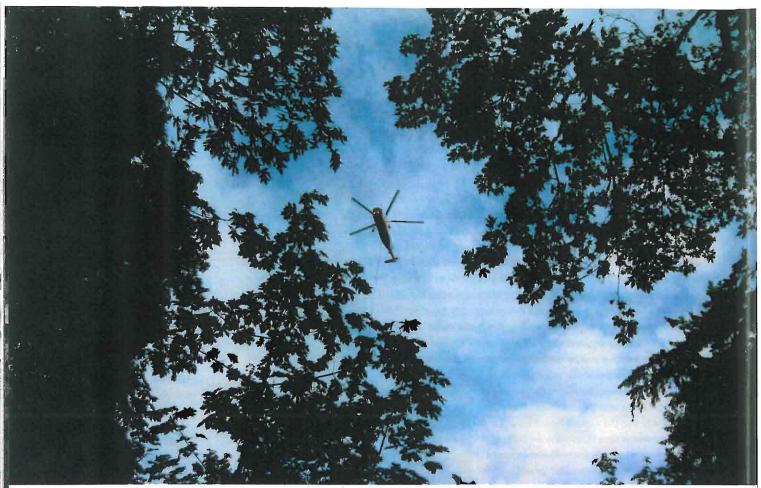
The proximity of the project to Sea-Tac International Airport required close coordination with the Federal Aviation Administration. PACE Engineers/SWSSD

FAA coordination. Since this project was slightly more than 1.6 km (1 mi) from Sea-Tac International Airport, close coordination with the Federal Aviation Administration (FAA) was required to not only stay out of the airport airspace, but also because the FAA limited the flight path the helicopter could take while transporting materials. Fortunately, the entire location between the staging area and the pipe failures was on forested SWSSD property that contained no houses within the potential crash zone.
